Rimkus Consulting Group, Inc.
Eight Greenway Plaza, Suite 500
Houston, TX 77046
(800) 580-3228 Telephone
(713) 623-4357 Facsimile

Re: RCG File No: 11009971
LLV Number: 0209452
VMF Location: 1530 Greensmark Drive in Houston, Texas
Subject: Final Report

Rimkus Consulting Group, Inc. was retained to examine LLV 0209452, VIN 1GBCS10E4M2908832. The fire occurred on June 13, 2016 at around 12:30 P.M. the operator of the vehicle at the time of the fire, was unavailable for interview but reportedly stated the vehicle's engine died while delivering mail on his route and backfired during subsequent attempts to restart it. Soon thereafter, smoke was observed from beneath the hood as well as flames.

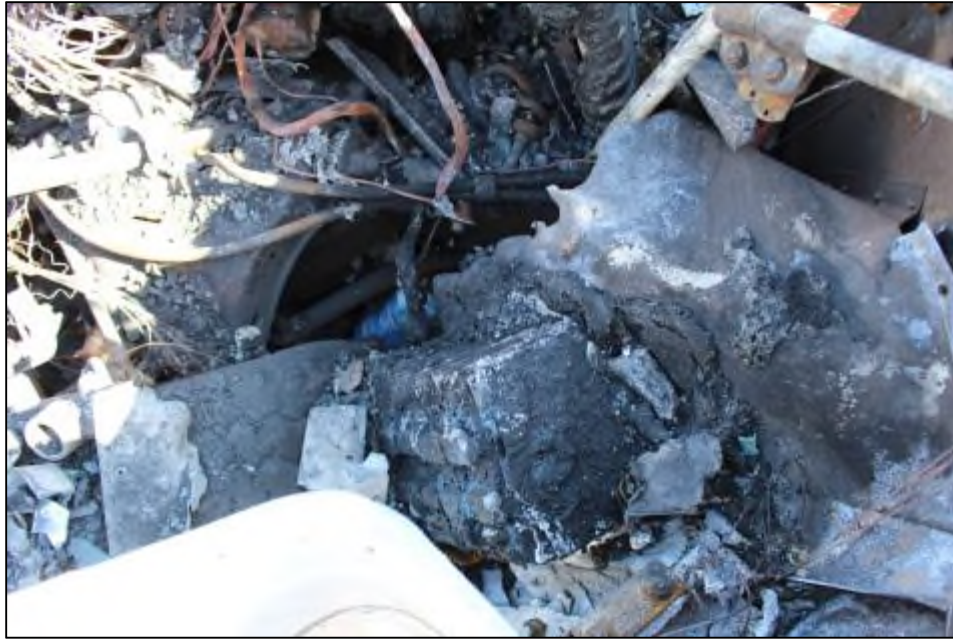
Photograph 12

Remains of battery on right side.

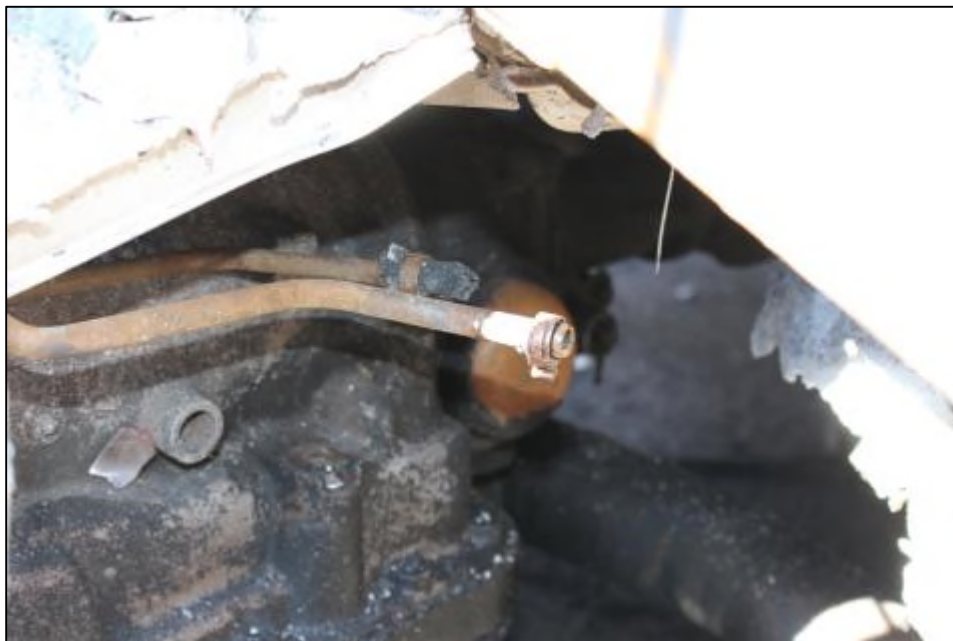
Photograph 13

Remains of fuel lines.

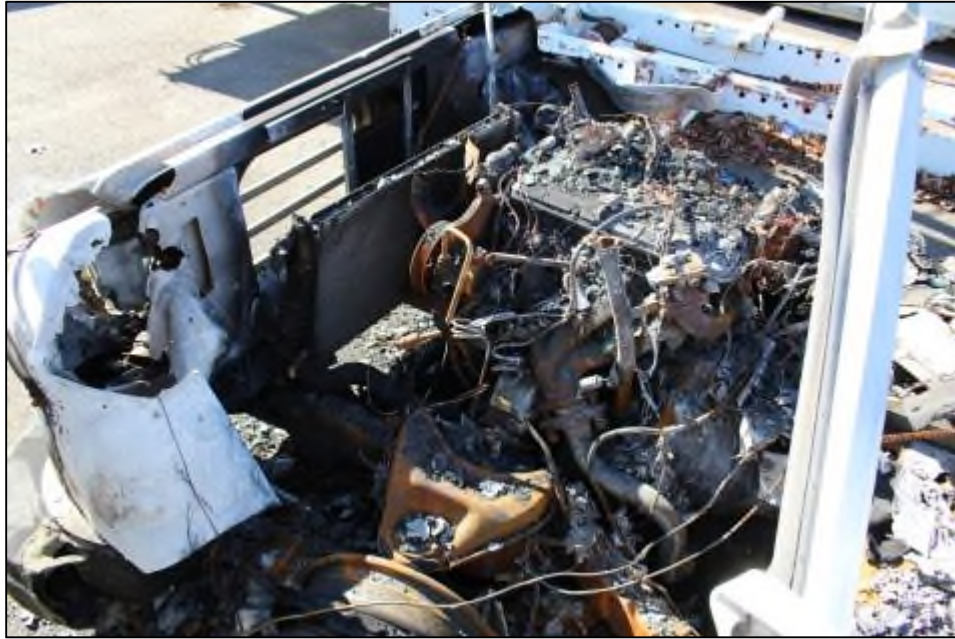
Photograph 14

Area of origin along left side.

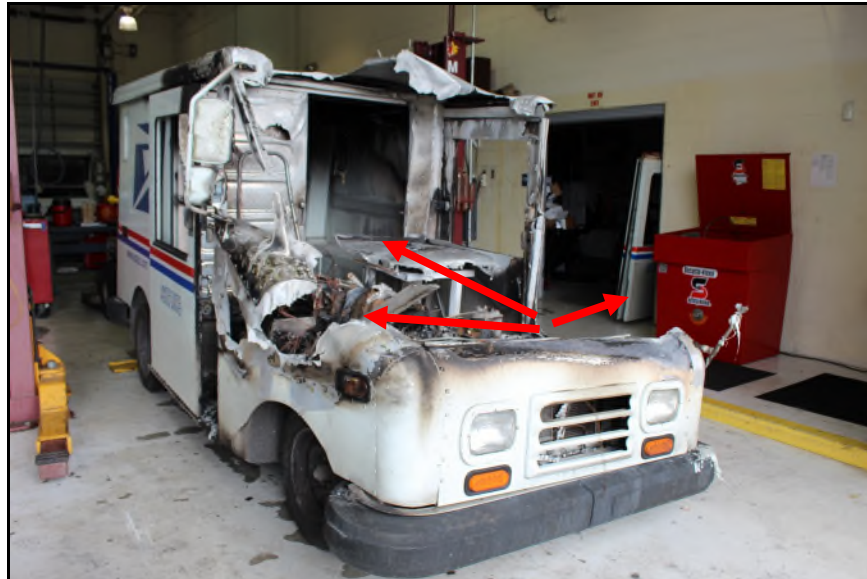
Photograph 1

Examination of the vehicle began at the front exterior and continued in a clockwise direction. The front grill lights and driver side quarter panel were observed with moderate fire damage and were mostly intact. The mail side quarter panel and the hood were consumed by the fire. The windshield and roof, above the operator's compartment, were observed to be completely burned through. Both doors were observed with minor to moderate smoke and soot damage. The fire damage diminished toward the rear of the vehicle except for severe smoke and soot damage observed near the top of the rear overhead door, indicating the door was open at the time of the fire. All four tires were observed to be intact except for moderate fire damage observed on the left mail side, front tire, that was positioned below the area of origin. The brakes, bearings and wheel hubs were intact on all the tires and were eliminated as potential causes of the fire. Exterior fire patterns indicated the fire originated on the mail side of the engine compartment above the level of the tires.

View of the front, right side of the LLV. Note the direction of the fire's extension.

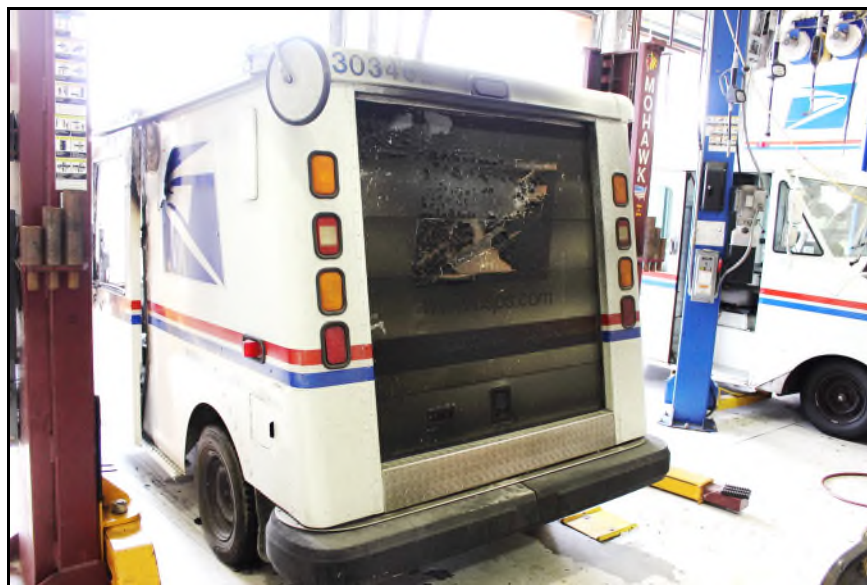
Photograph 2

The rear interior of the cargo compartment was observed with moderate smoke and soot damage and minor fire damage near the opening to the interior compartment. Where fire patterns indicated the fire had extended from the direction of the engine compartment.

View of the rear, cargo area. Note that other than the smoke and soot on the rear cargo door, most of the fire damage was observed at the front of the LLV.

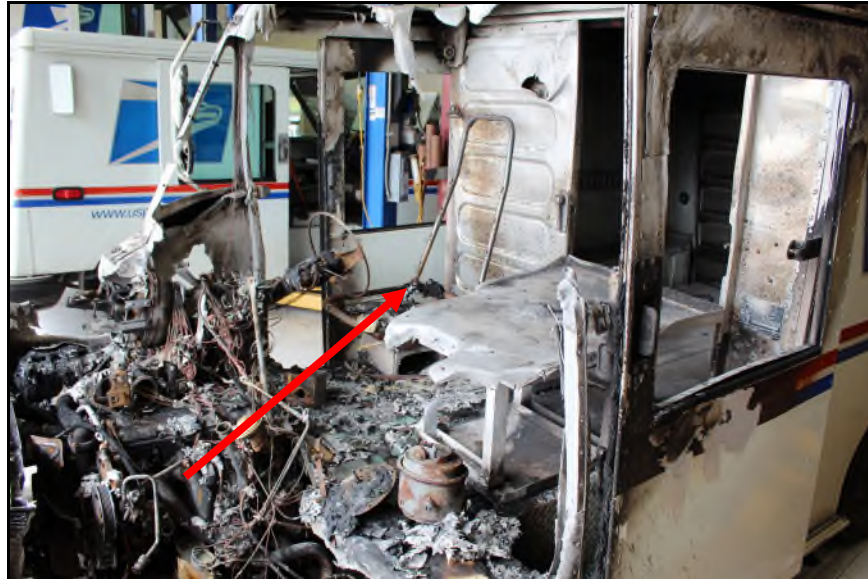
Photograph 3

The interior operator's compartment was observed with moderate to severe fire damage with most of the damage observed along the engine compartment bulkhead. The front windshield and roof, constructed with lightweight aluminum, had completely burned through and were consumed by the fire. The front half of the aluminum mail tray was melted, as was the combustible material on the driver's seat, with fire patterns indicating this was due to an extension of the fire from the engine compartment.

View of the interior, operator's compartment. Note the fire extended from the engine compartment.

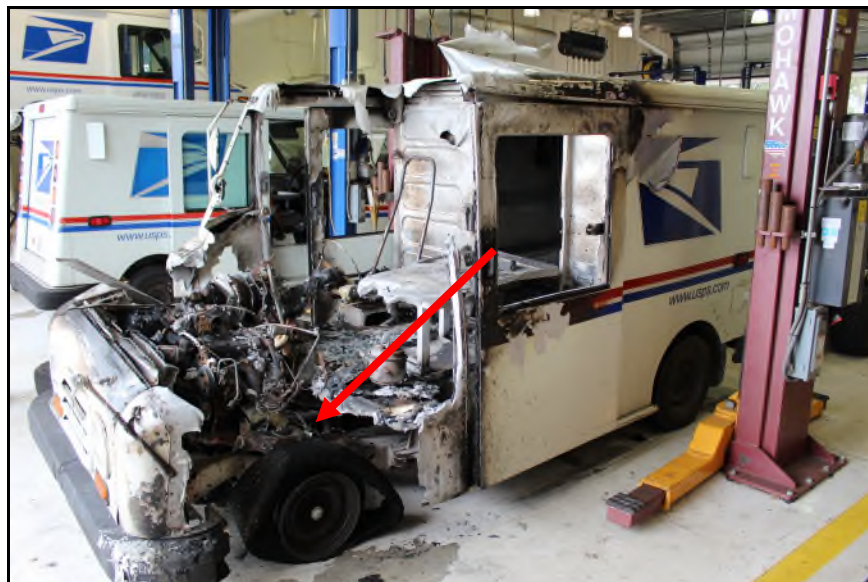
Photograph 4

View showing the fire damage on the mail side of the vehicle. Note the front quarter panel was completely burned through.

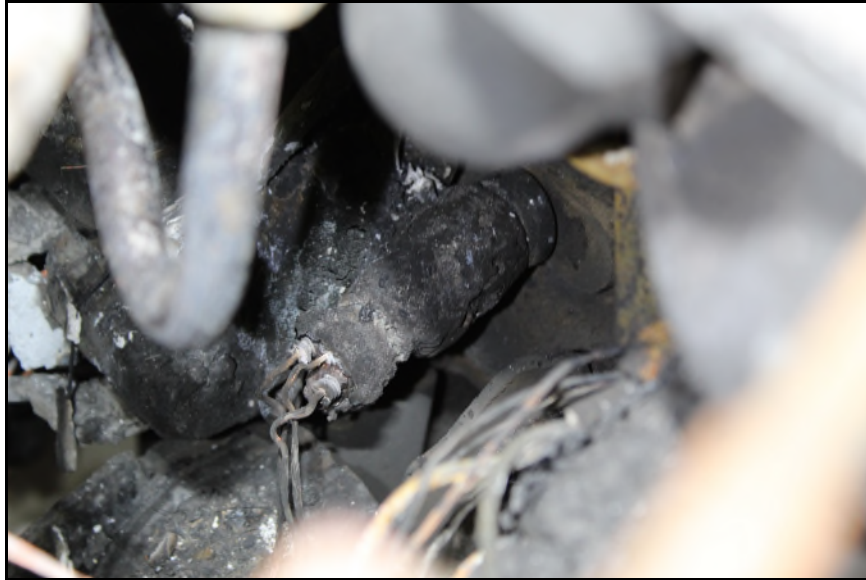
Photograph 7

3. The specific ignition sequence and cause of the fire was inconclusive due to the severity of damage in the area of origin; however, the possibility that adverse electrical activity occurred between the ignition coil pack and one of the spark plug wires causing sparks could not be eliminated as the potential cause of the fire.
4. The vehicle had been misfiring earlier in the mail delivery route indicating a potential problem with the ignition coil or connections.

View of the ignition coil pack positioned on the opposite side of the engine.

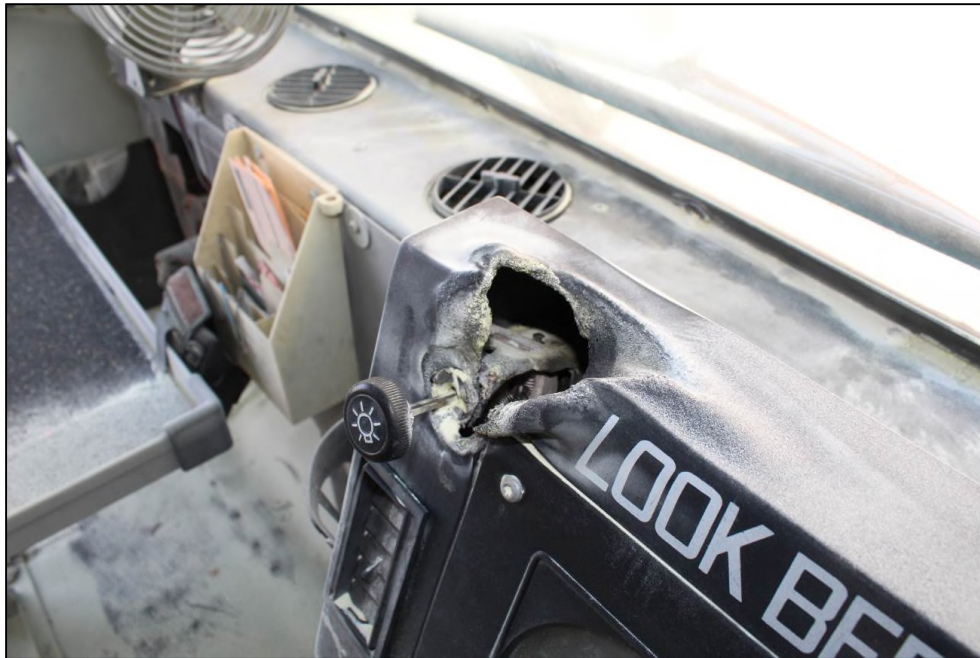
Photograph 3

Fire damage at headlamp switch.

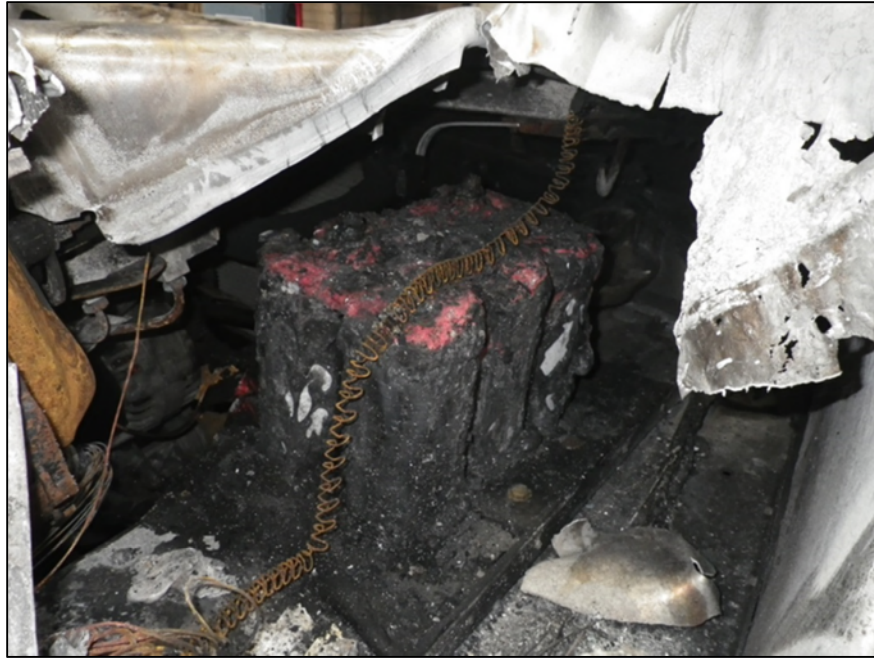
Photograph 5

The battery, minor fire damage observed.

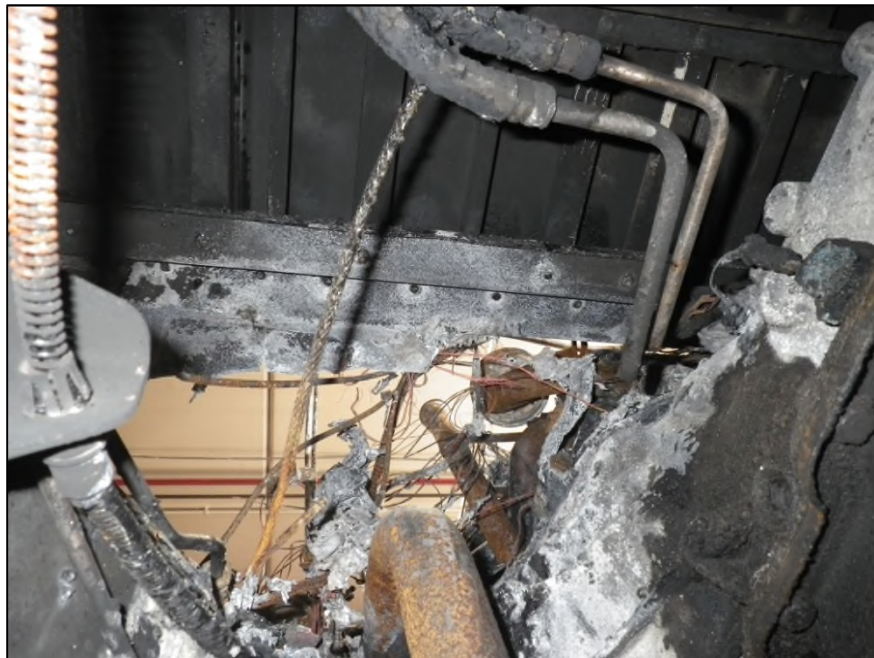
Photograph 6

Fuel lines and most severe fire damage to the mail side of the vehicle.

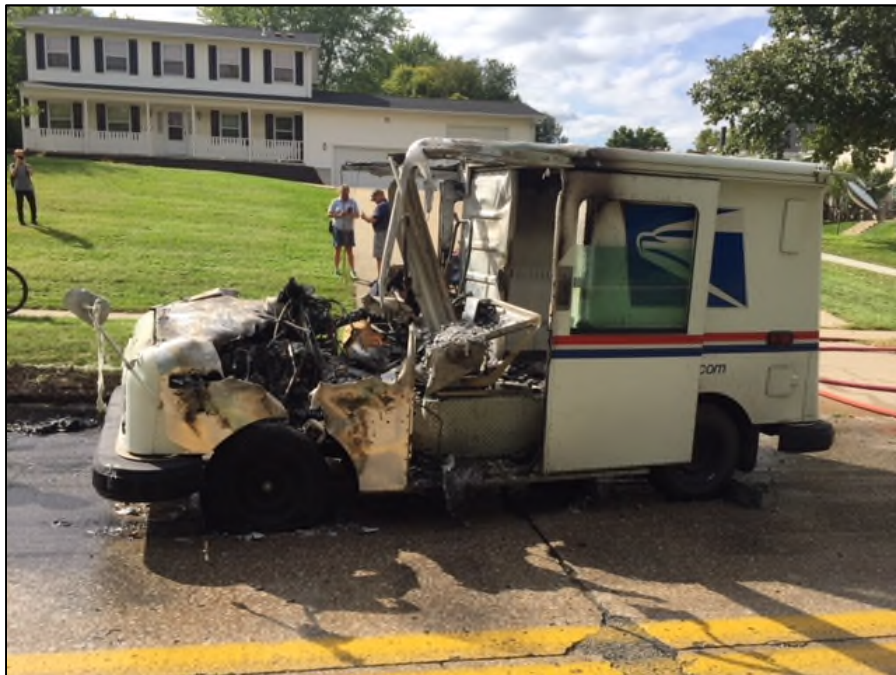
Photograph 8

Observe the severe fire damage to the engine and driver's compartment.

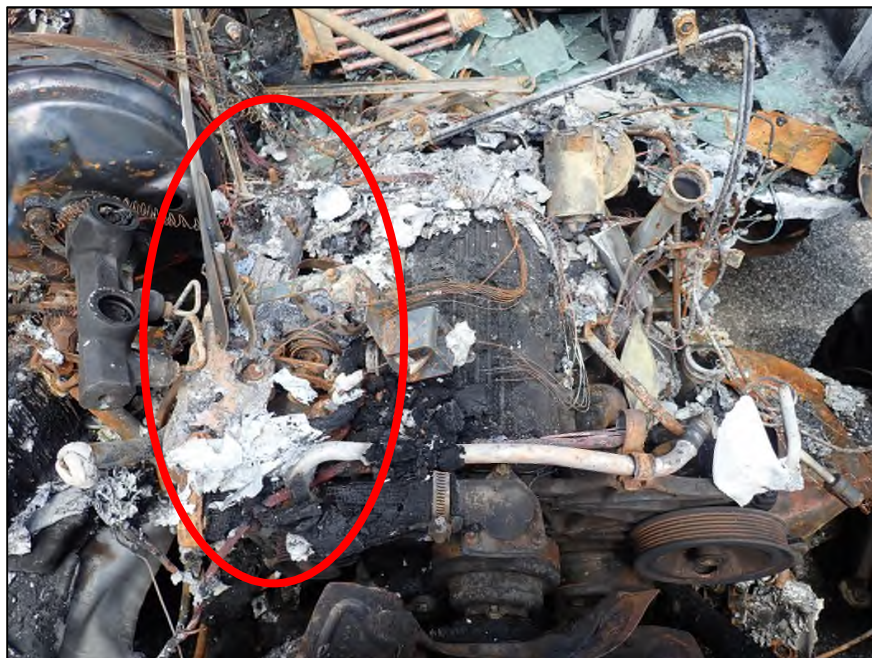
Photograph 8
View of the engine compartment with origin area notated.

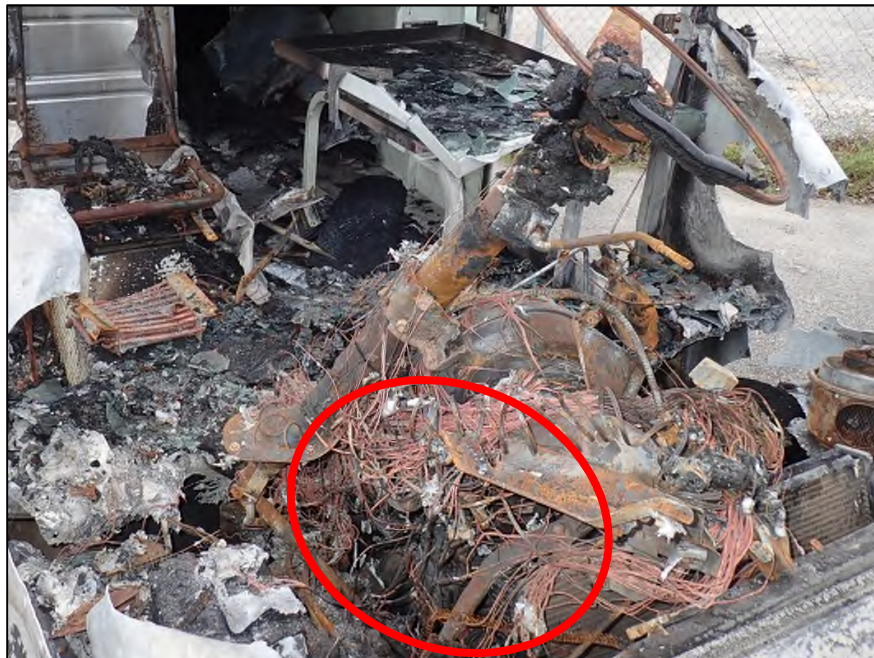
Photograph 10

View of the right side of the engine compartment with the origin area notated.

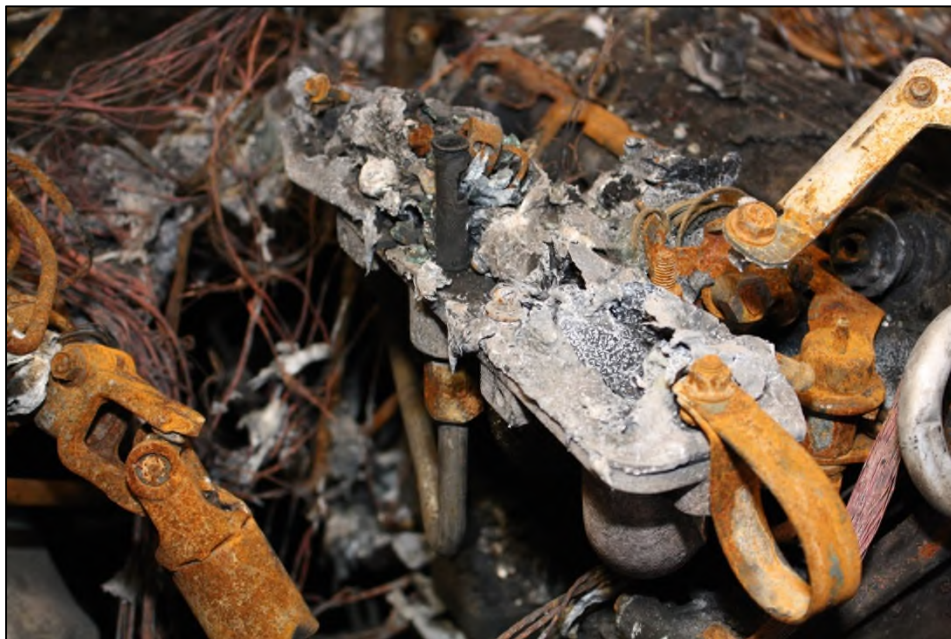
Photograph 4
Area of origin.

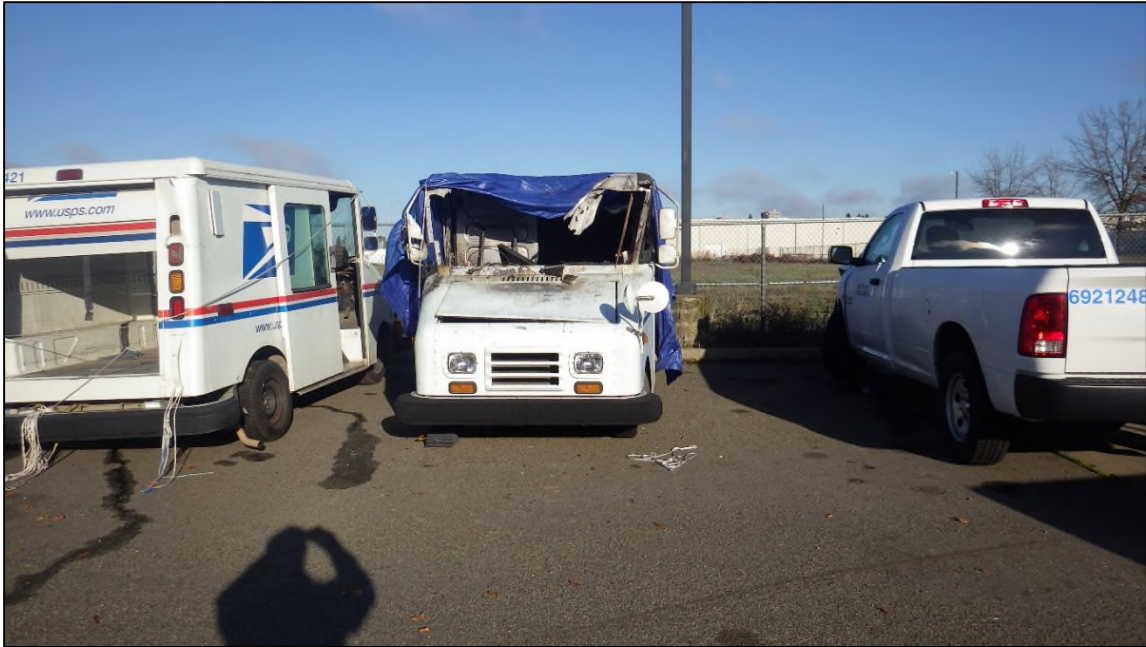
Photograph 1

View of the front of the vehicle.

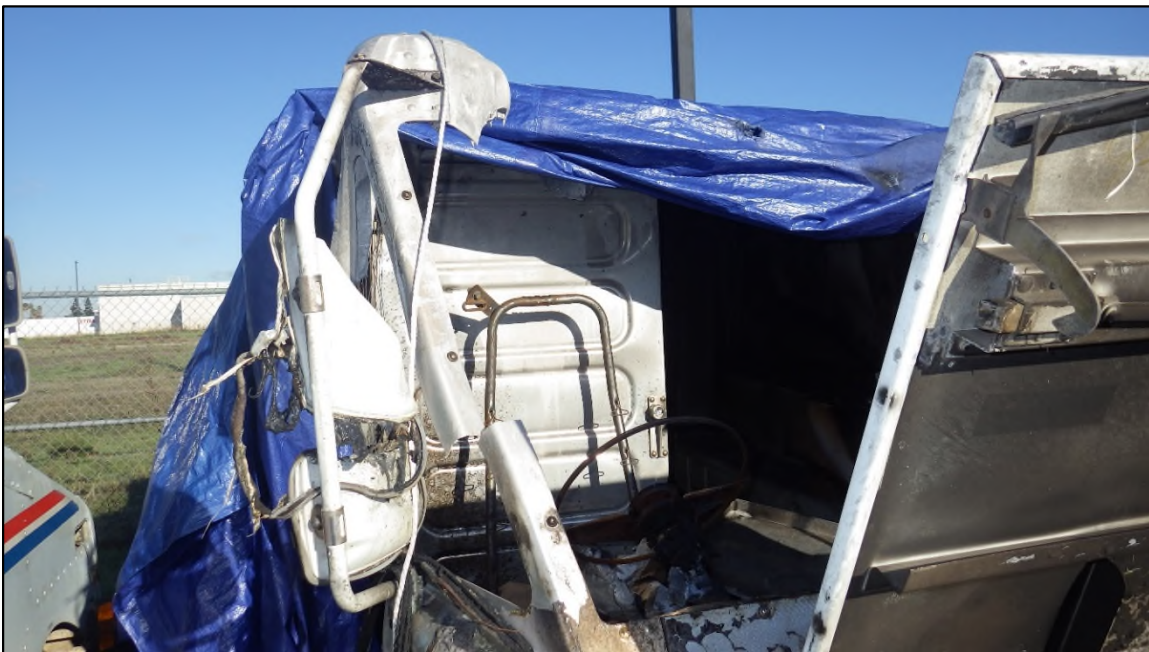
Photograph 2

A view of the driver's side.

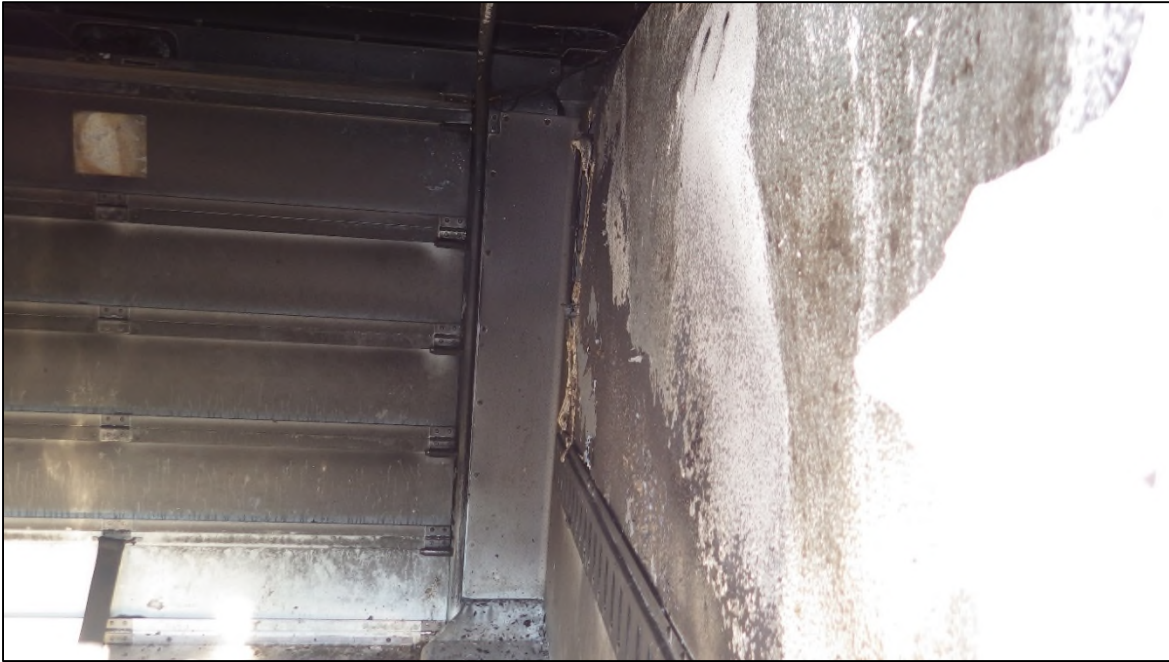
Photograph 3

A view of the rear cargo area.

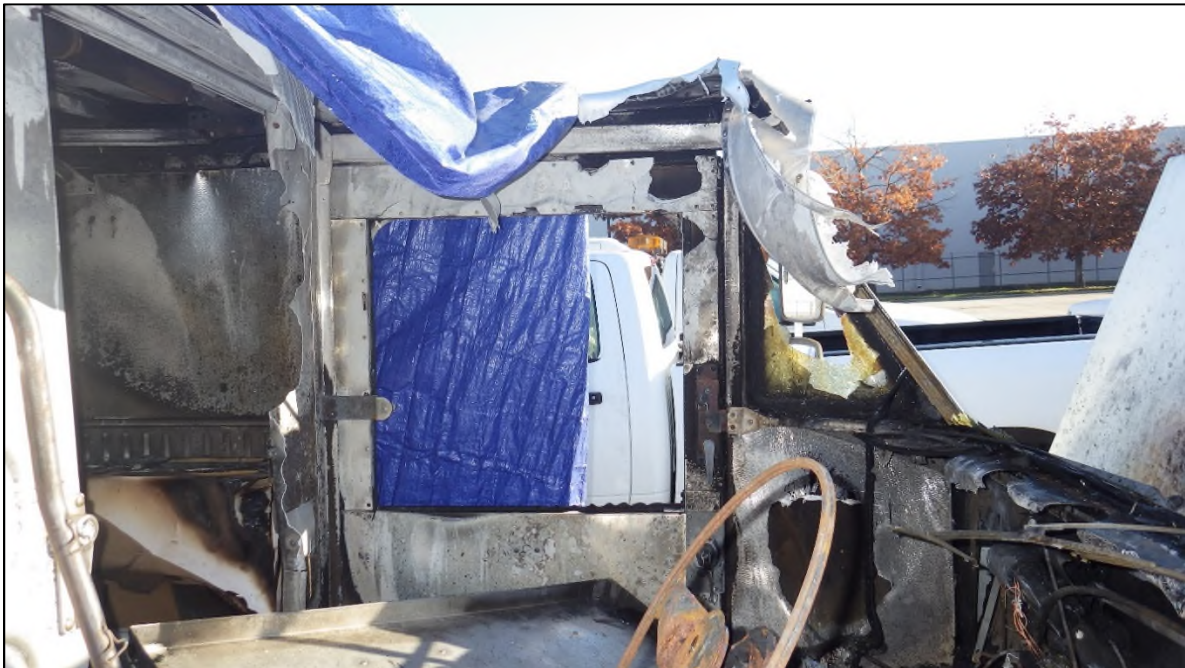
Photograph 4

A view of the passenger side cab inside.

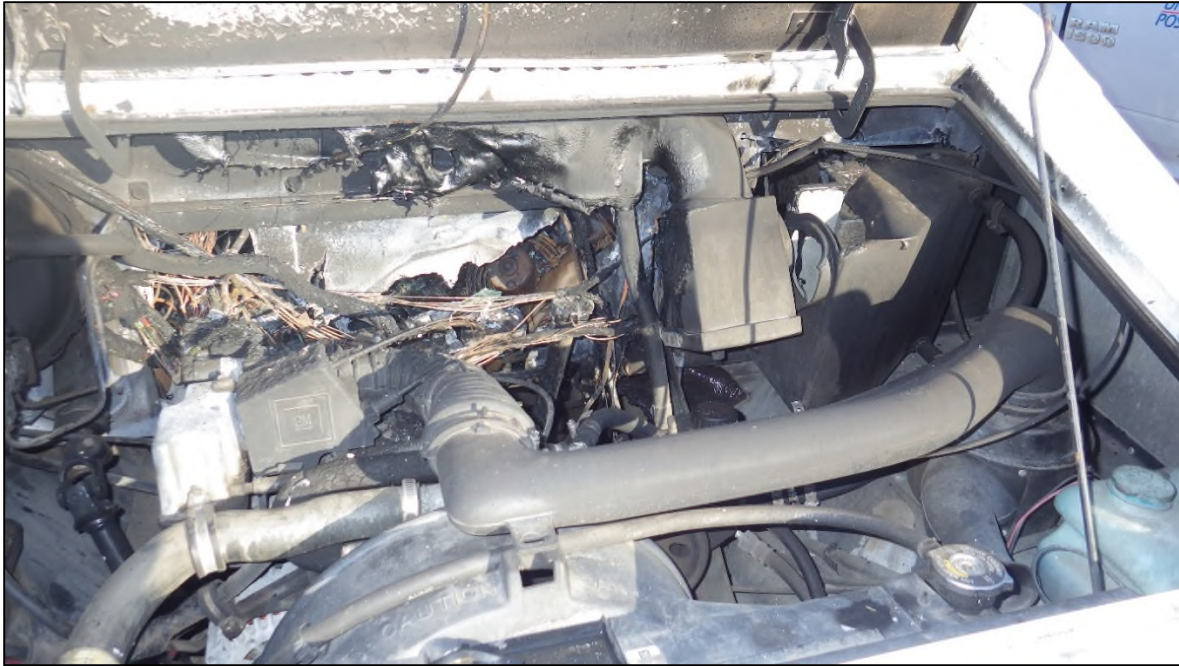
Photograph 5

A view of the engine compartment.

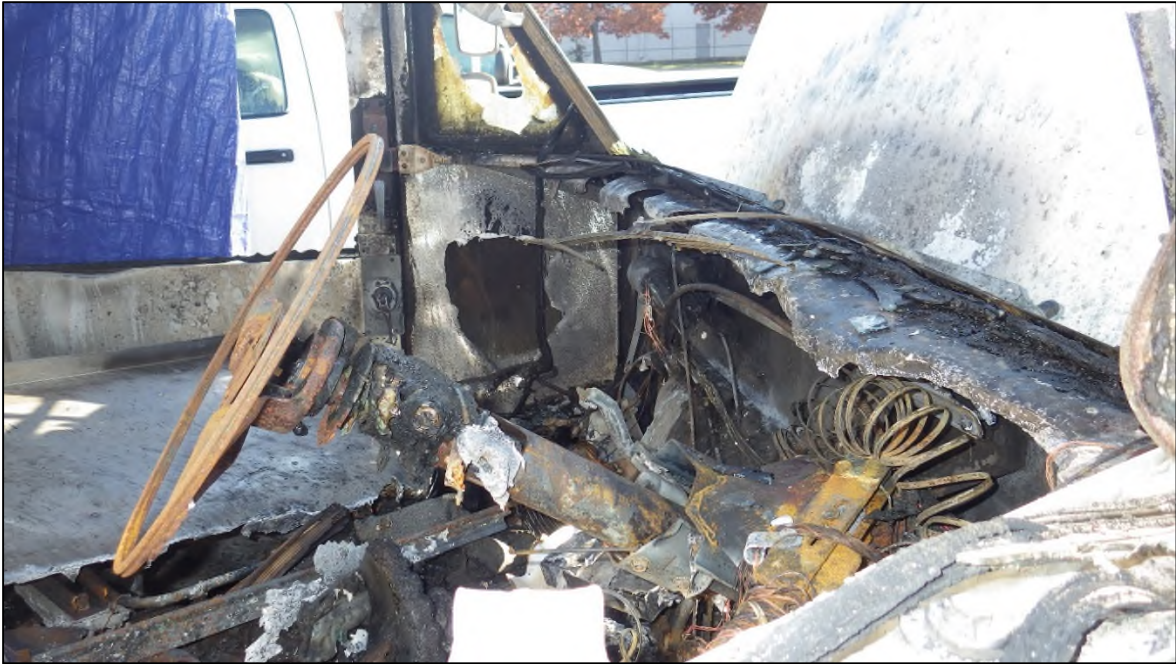
Photograph 7

A view of drivers compartment with steering column in place.

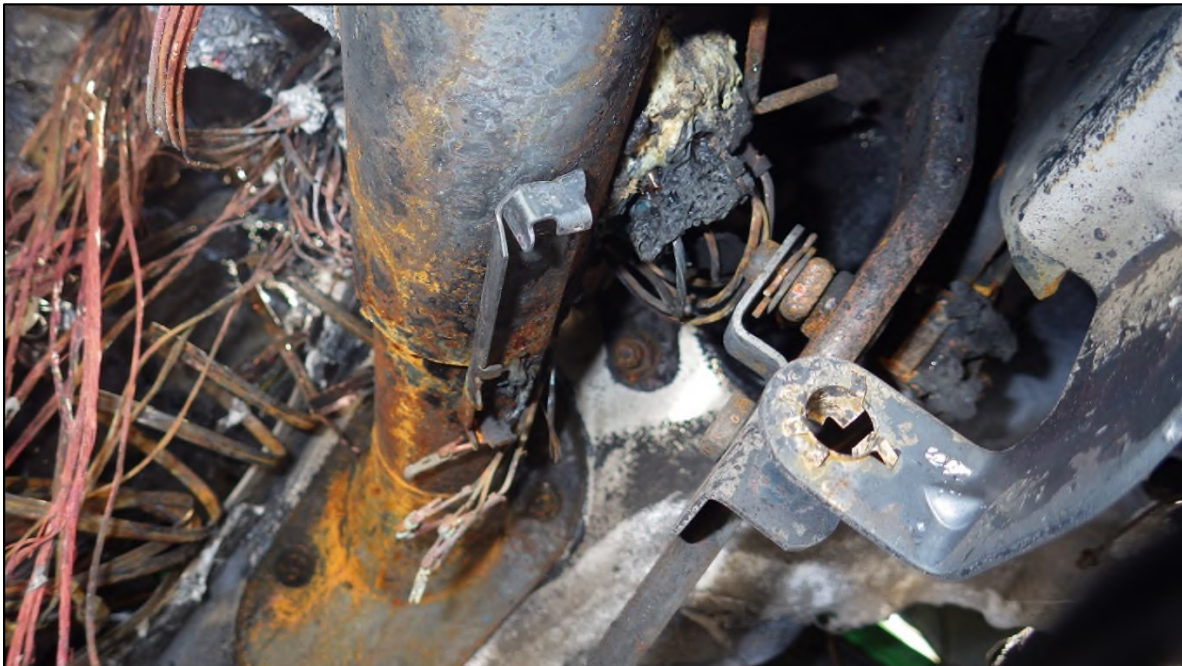
Photograph 8

Location where neutral safety switch used to be.

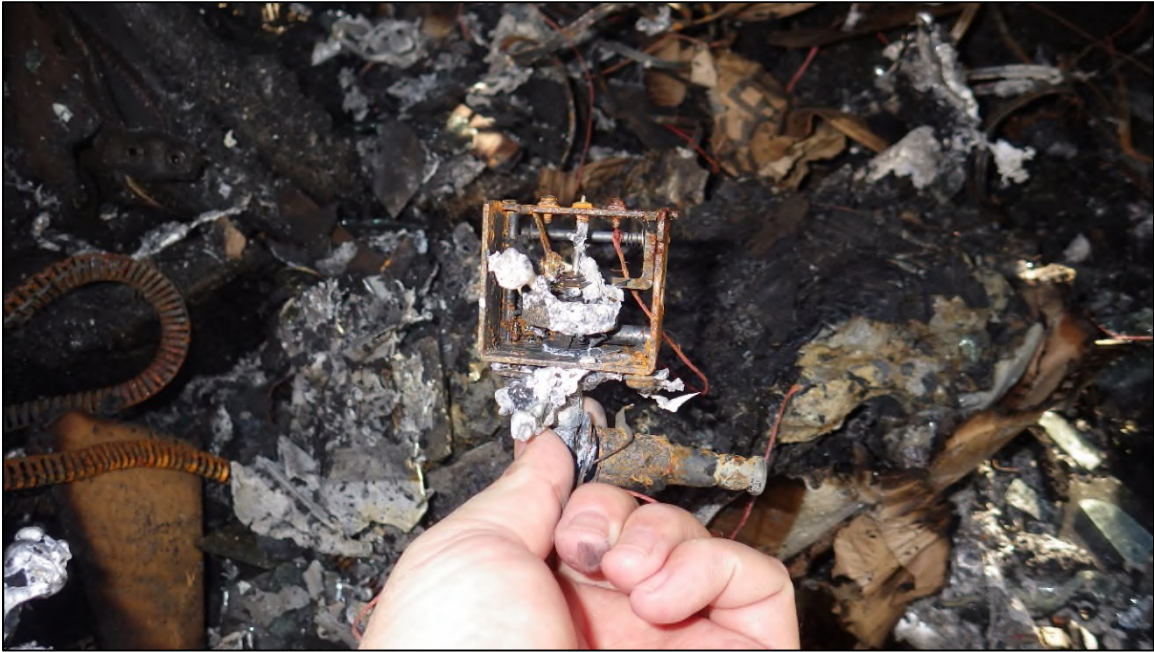
Photograph 9
Headlight switch remains.

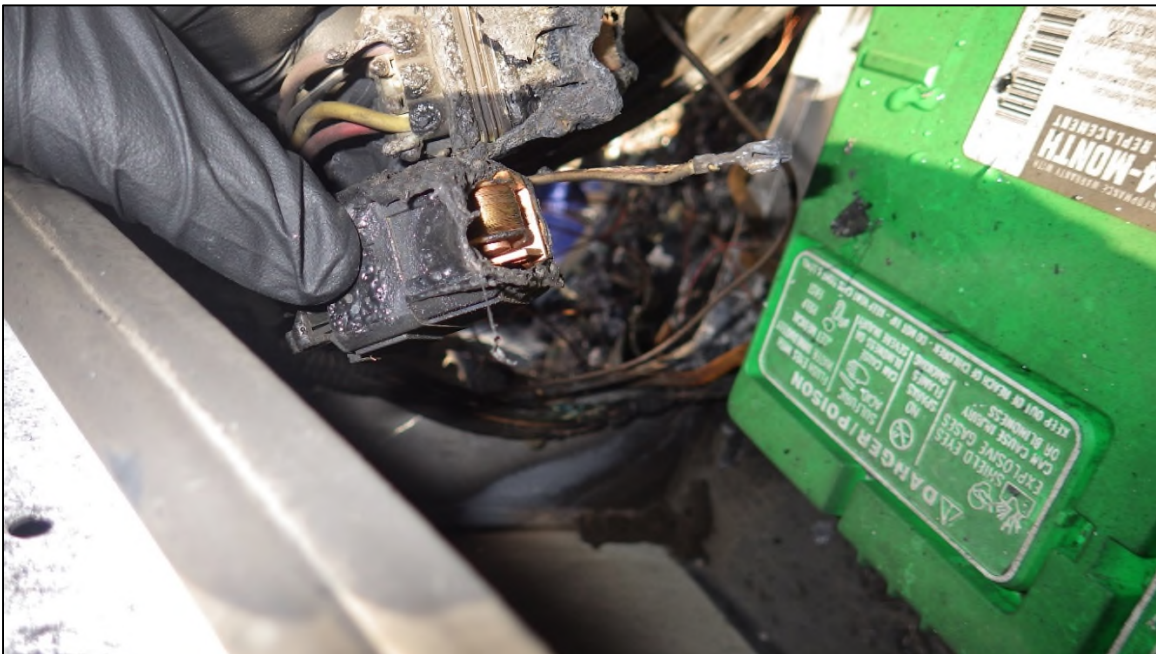
Photograph 10
A view of the flasher unit attacked by fire.

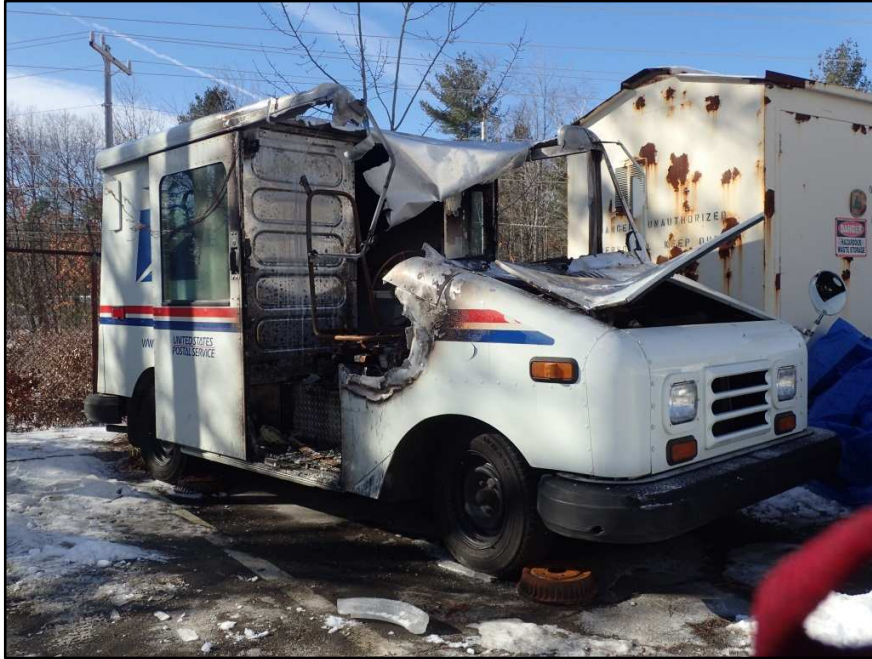
Photograph 1

Front and driver's side of LLV 4304603.

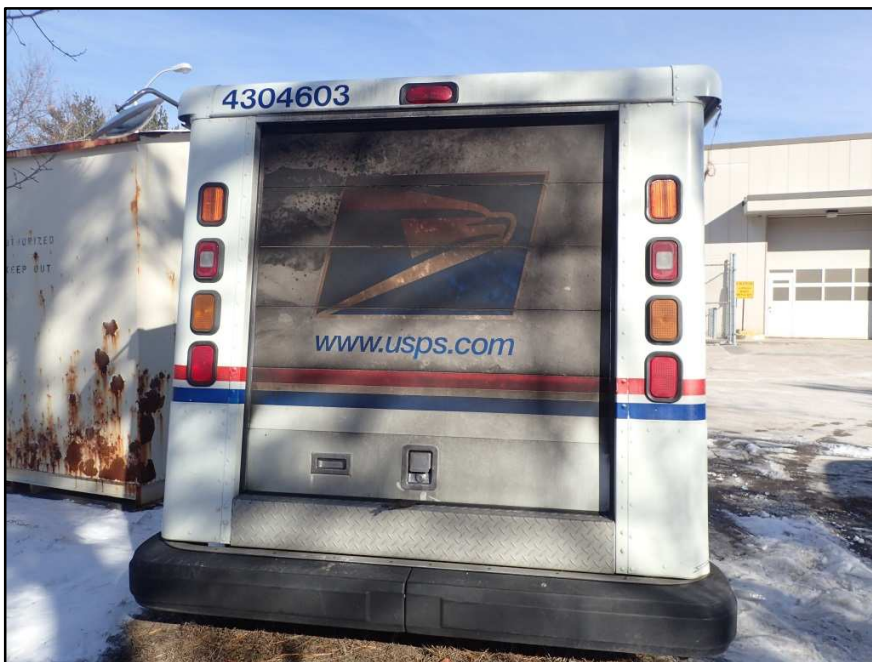
Photograph 2

Rear of LLV.

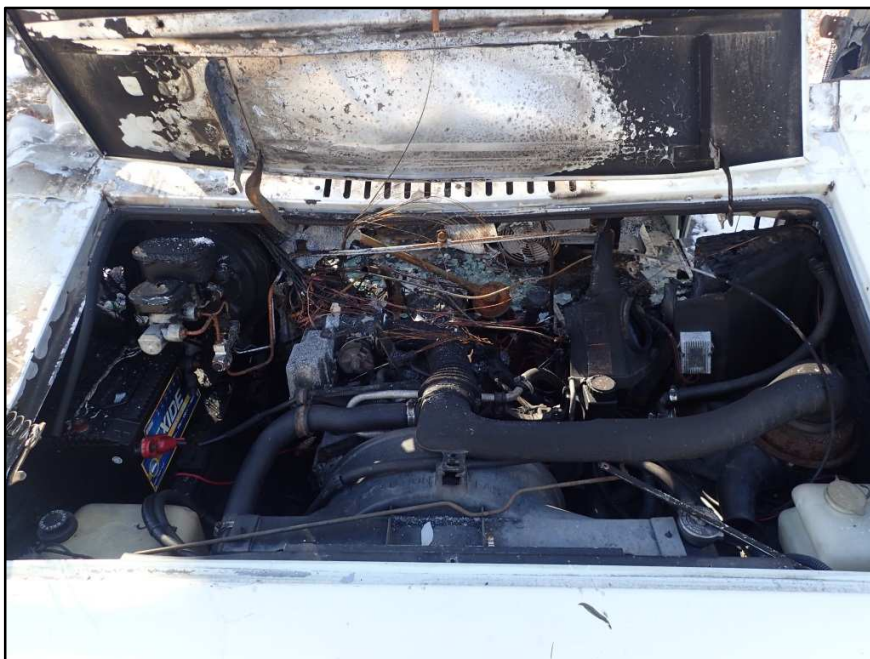
The engine compartment was examined from above. The engine hood was damaged and bent from the fire department extinguishment operations. The middle of the hood had a small movement and intensity fire pattern indicating a fire progressing from the interior of the vehicle and moving to the engine compartment. The battery was intact and free of fire damage. The electrical conductors near the battery and in the engine compartment were examined and we did not observe any adverse electrical activity or anomalies. Flame impingement was observed to the engine components that were near the fire wall. The fire had consumed the aluminum fire wall when the fire progressed from the interior of the vehicle to the engine compartment. Most of the plastic and rubber engine components sustained directional melting but remained intact. Based on the fire patterns within this area, the engine compartment was eliminated as the area of origin. The vehicle was equipped with a GM fuel filter system.

Photograph 4
Engine compartment.

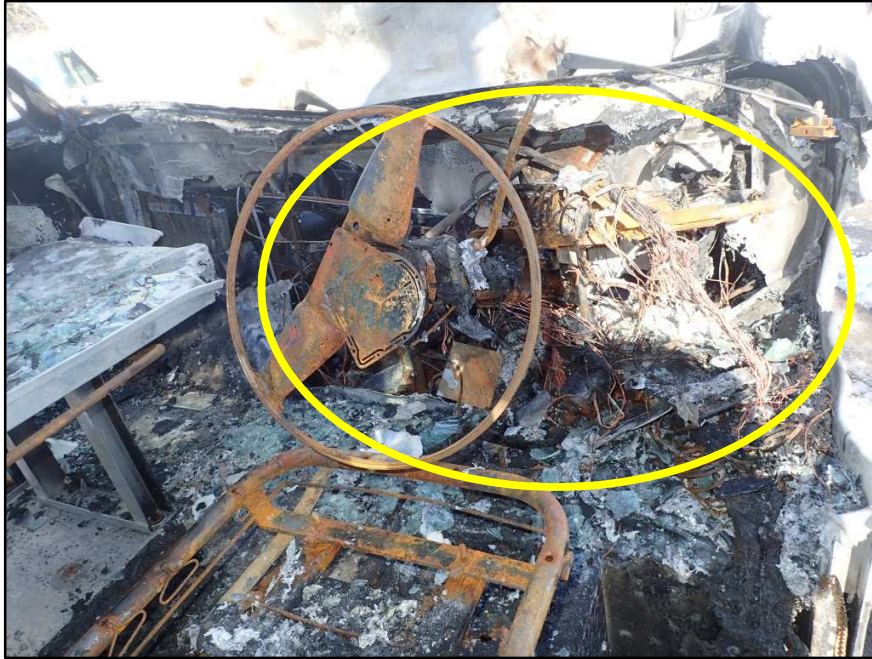
Photograph 5

It is our opinion, based on the observed pattern of fire damage and a systematic evaluation of the remaining physical evidence and an eye witness that the fire originated at the dashboard of the vehicle. The specific area of origin could not be conclusively identified at the time of our inspection due to the severity of the damage and the lack of conclusive physical evidence.

Dash board and the area of origin.

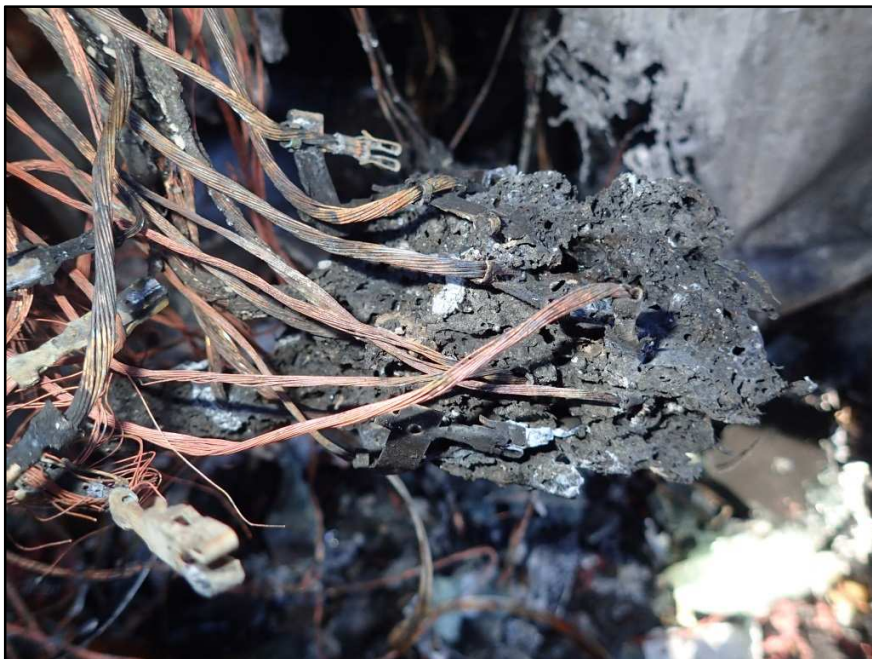
Photograph 6

Remains of the fuse panel.

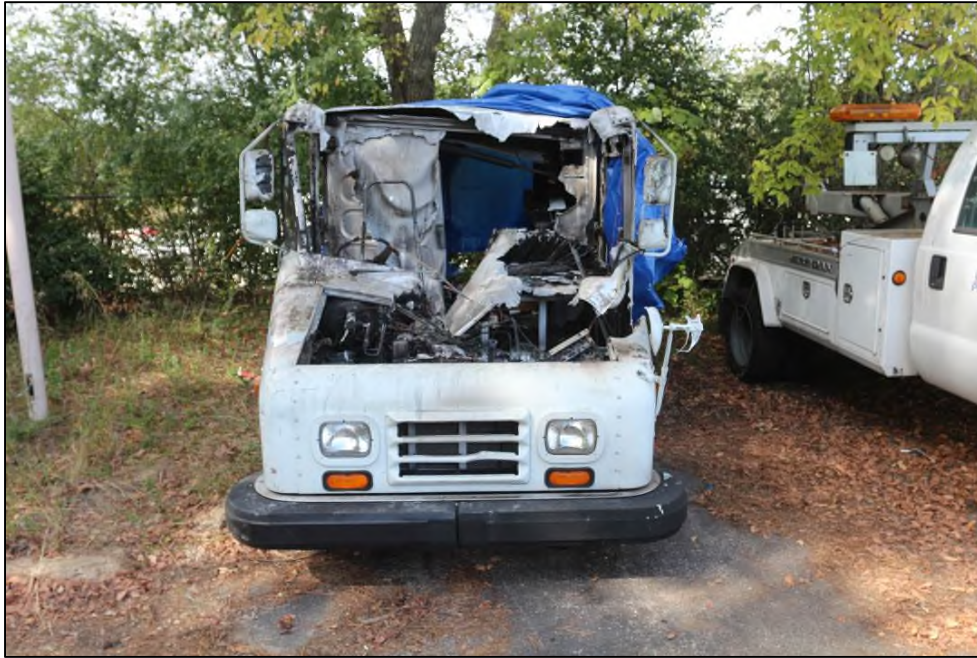
Photograph 1

A view of the front.

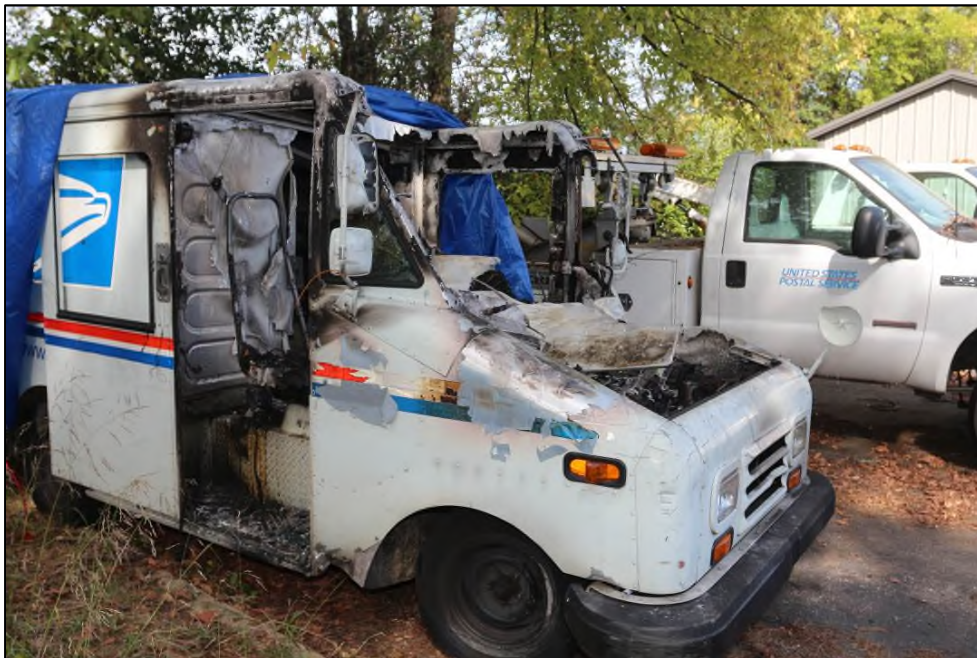
Photograph 2

A view showing the driver's side.

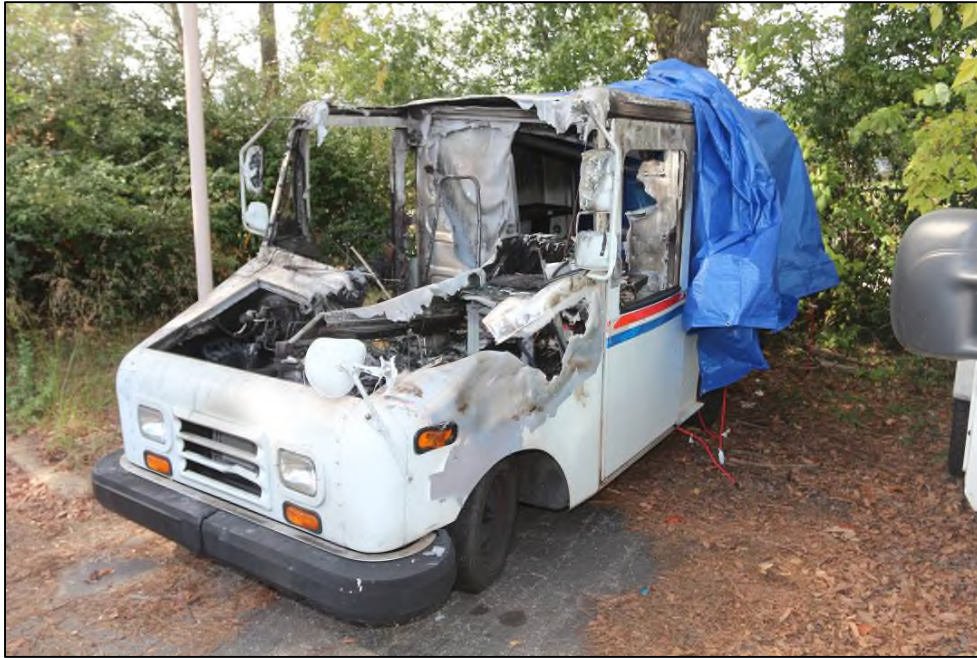
Photograph 3

A view of the mail side.

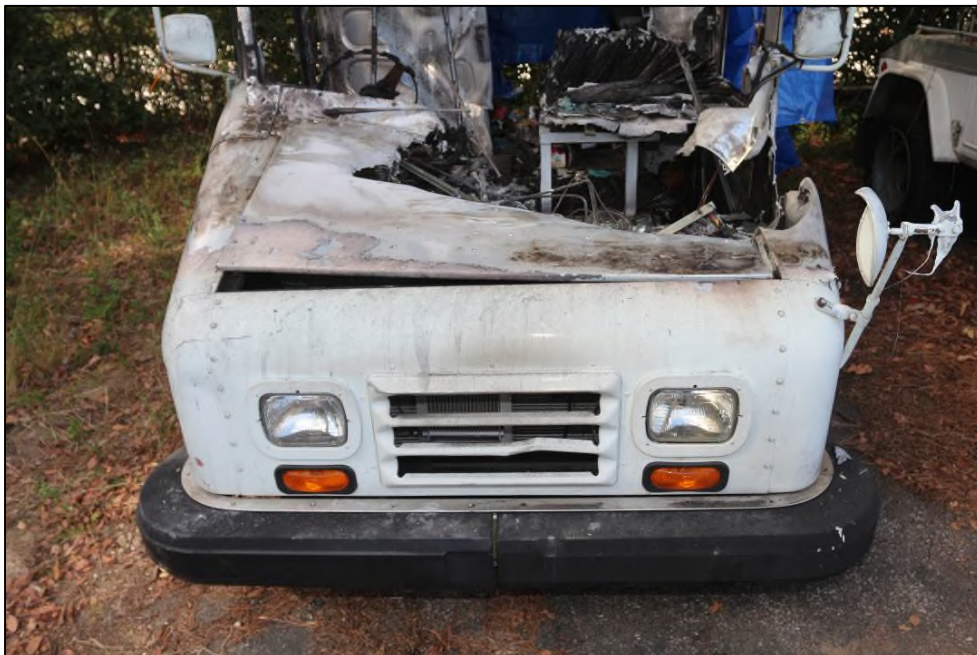
Photograph 4

A view of the hood area showing the mass loss of the windshield frame and roof structure.
